# Various Environmental, Zoning & Other Baseline Studies for NMIA

## Deliverable 8

December 2020

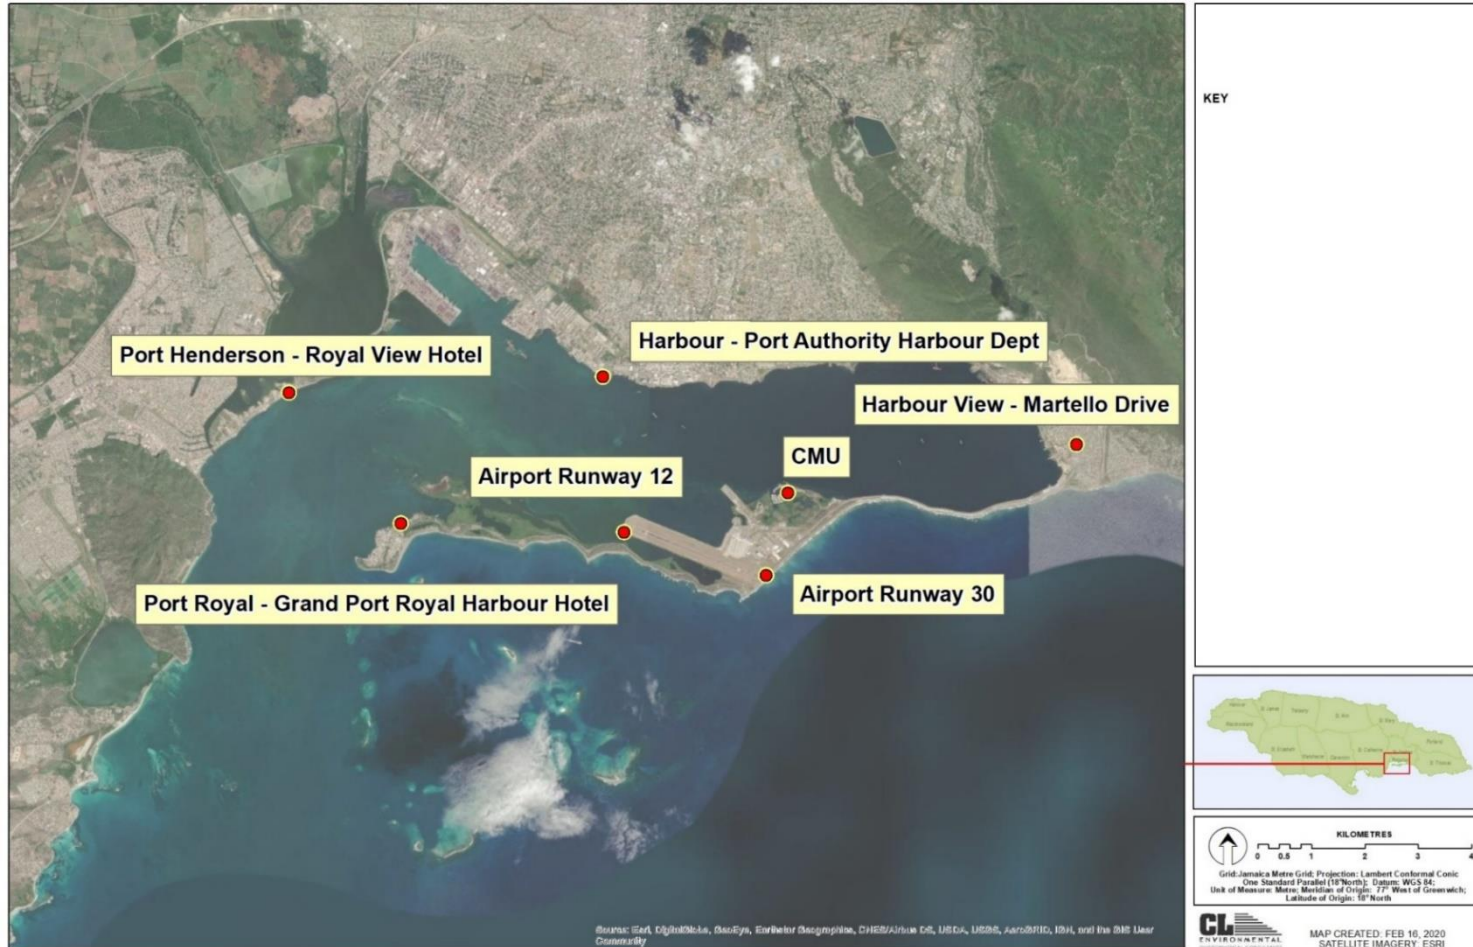
# Ambient Noise Survey Stations

Seven (7) noise meters were set up at each location to collect data every second for twelve (12) days (March 13 – 24, 2020).

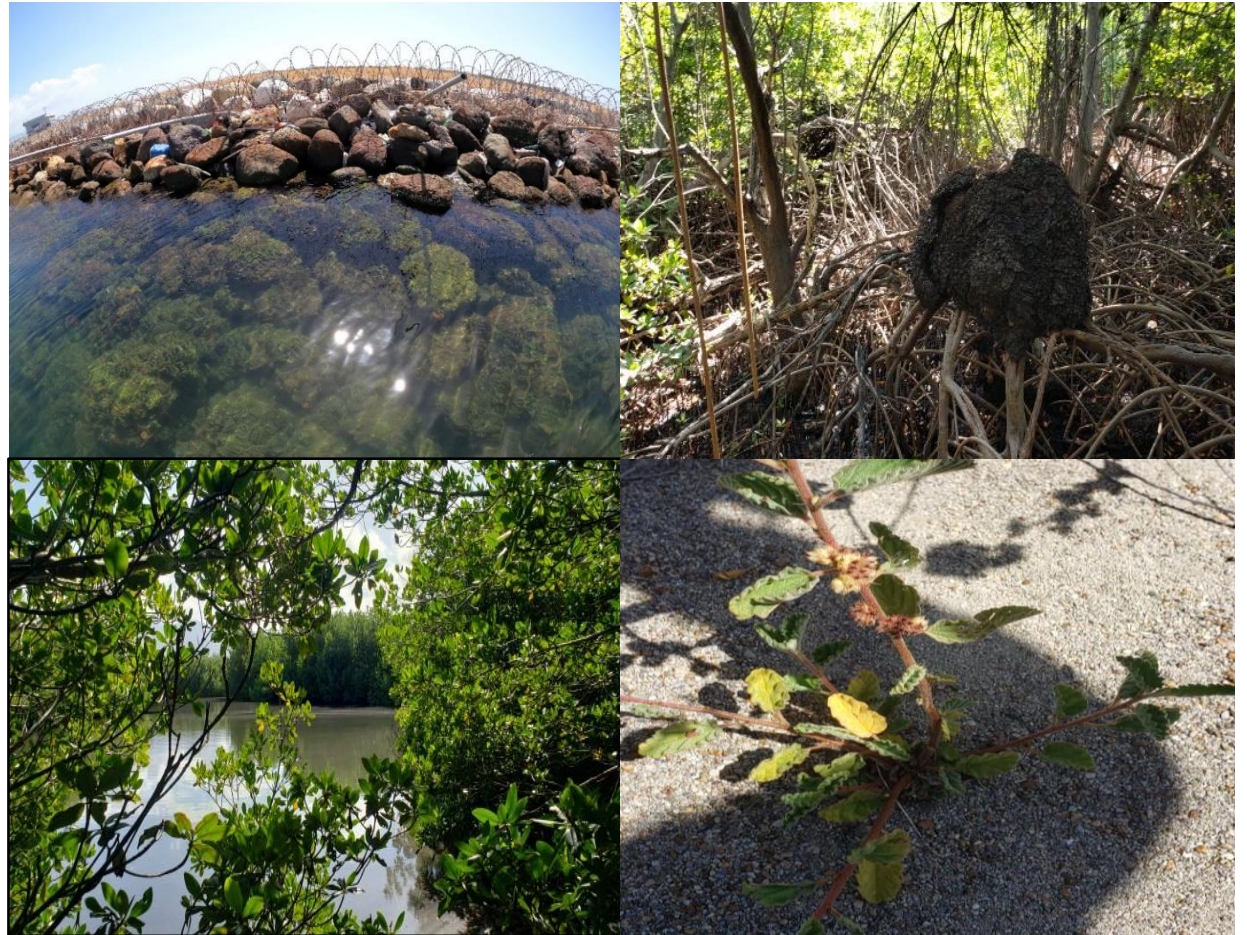
# Water Quality sample stations

Water quality analysis at twelve (12) stations across the harbour and within the vicinity of the airport environment were conducted on three (3) occasions: February 26, 2020, March 26, 2020, and April 9, 2020.

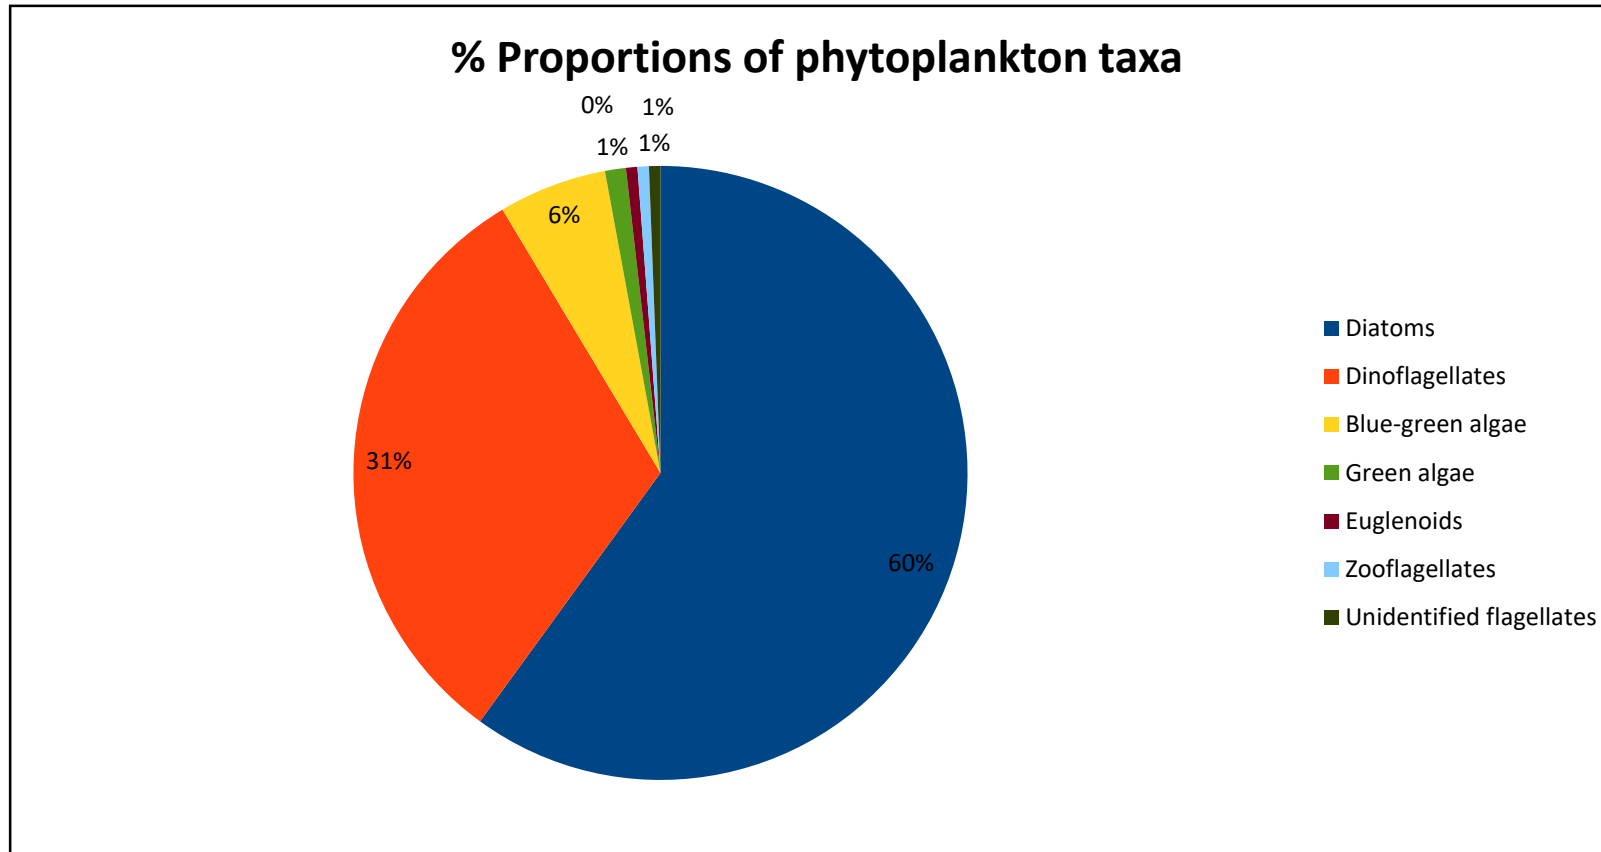
# Plankton Communities

The phytoplankton community of Kingston has moderately low diversity, high abundance values and dominated by diatom species which indicates that the area continues to be a eutrophic body of water.

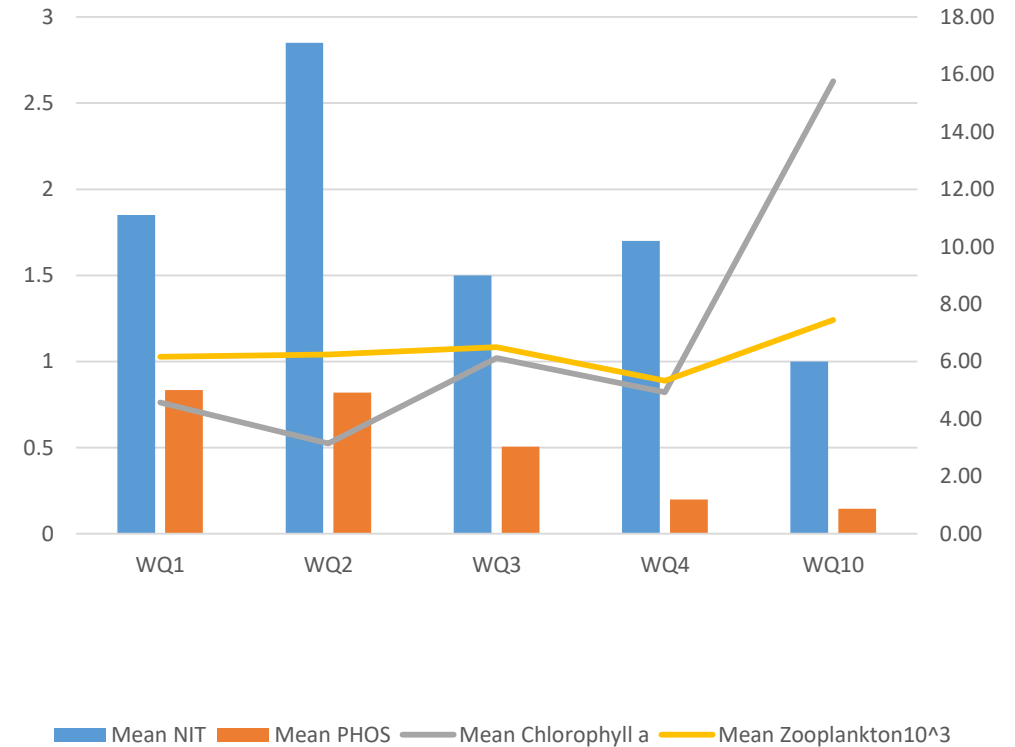
## Water Quality and Plankton Stations 1, 2, 3, 4 and 10

- High levels of Phosphates and Nitrates indicate Eutrophic conditions
- All stations exceeded the NEPA standards (Nitrates 0.007- 0.014, Phosphates 0.001-0.003)
- Station 10 had much larger plankton which utilizes the Nitrates and Phosphates
- Each station indicated eutrophic conditions for Mean Zooplankton

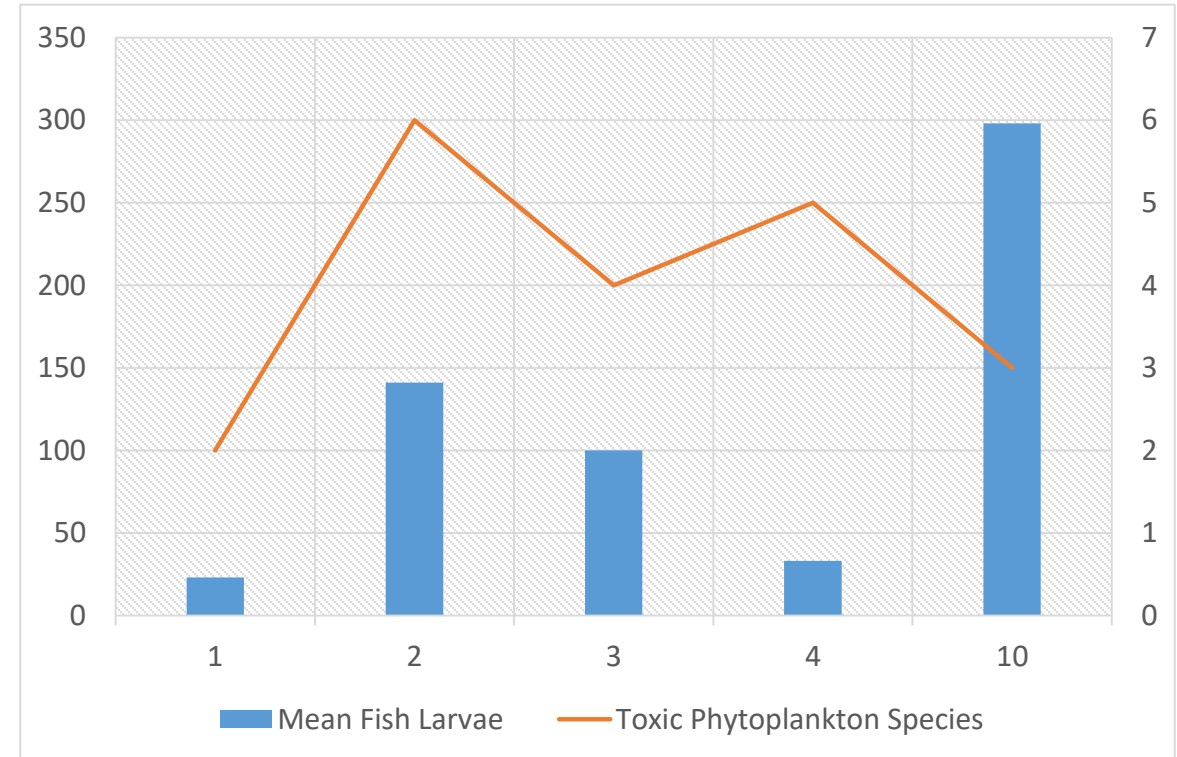
# Water Quality and Plankton Stations 1, 2, 3, 4 and 10

- No conch larvae was found at any station
- Lobster larvae counts were very low, with a mean of 1 at Stations 1 and 4
- Seven (7) potentially toxic phytoplankton species were identified in the water samples within the direct vicinity of the Airport.
- These species have the ability to produce toxins which may poison fish and shellfish.
- Noteworthy- mangrove and seagrass areas had little or no larvae

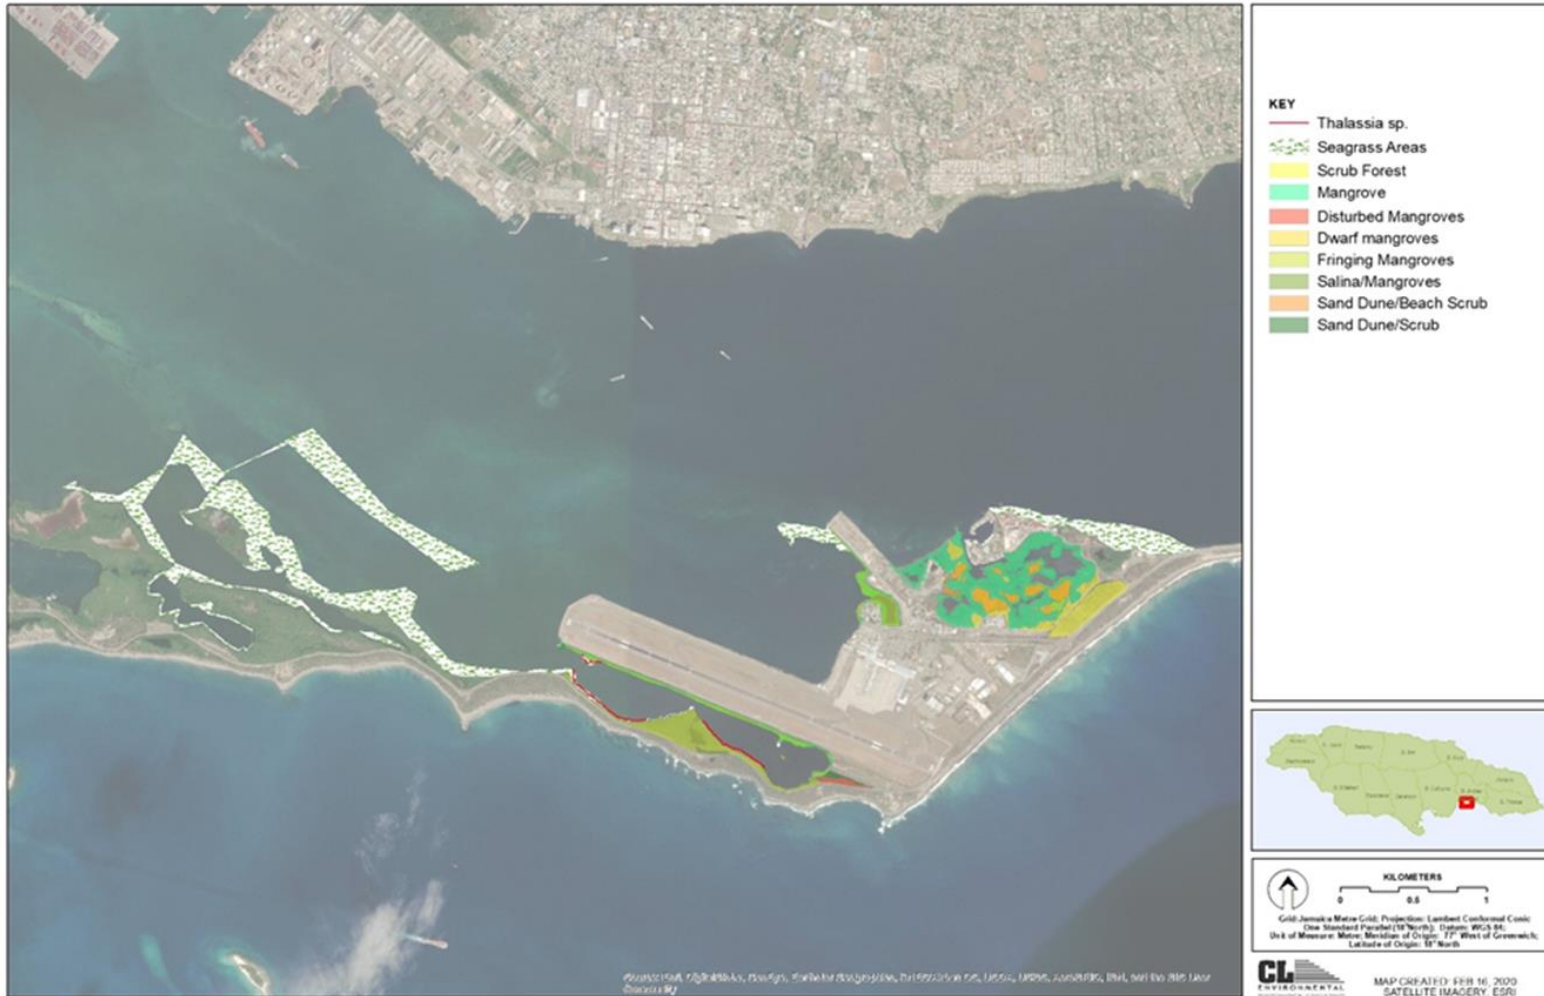
# Habitat Map

Ecologically Sensitive Habitats in PPRPA

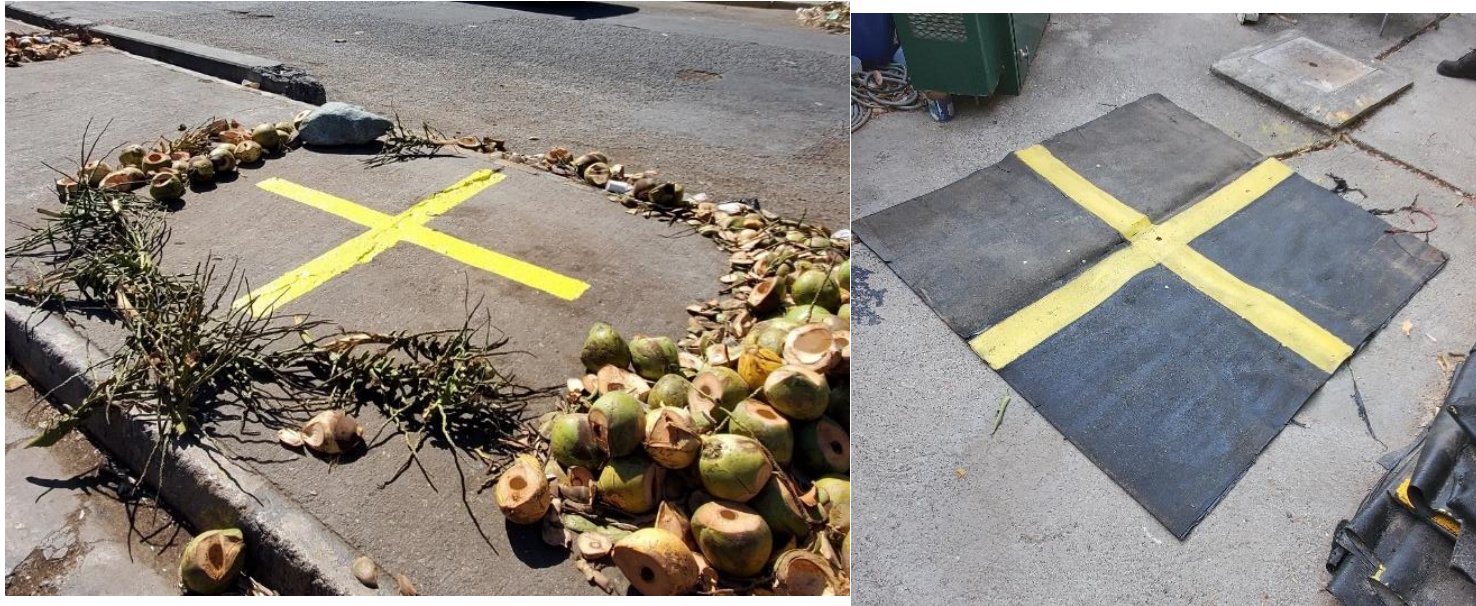
### LiDar Ground Control Points (GCP)

- This survey was necessary as it supported the aerial survey by providing it with ground controls relative to a horizontal and vertical datum.
- 22 GCPs were established and surveyed and was spatially distributed over the Aerial Survey area which encompassed parts of Kingston and Portmore..
- The GCPs were observed using Static Global Navigation Satellite System (GNSS) surveying techniques which had a minimum observation time of 60 minutes for each GCP.

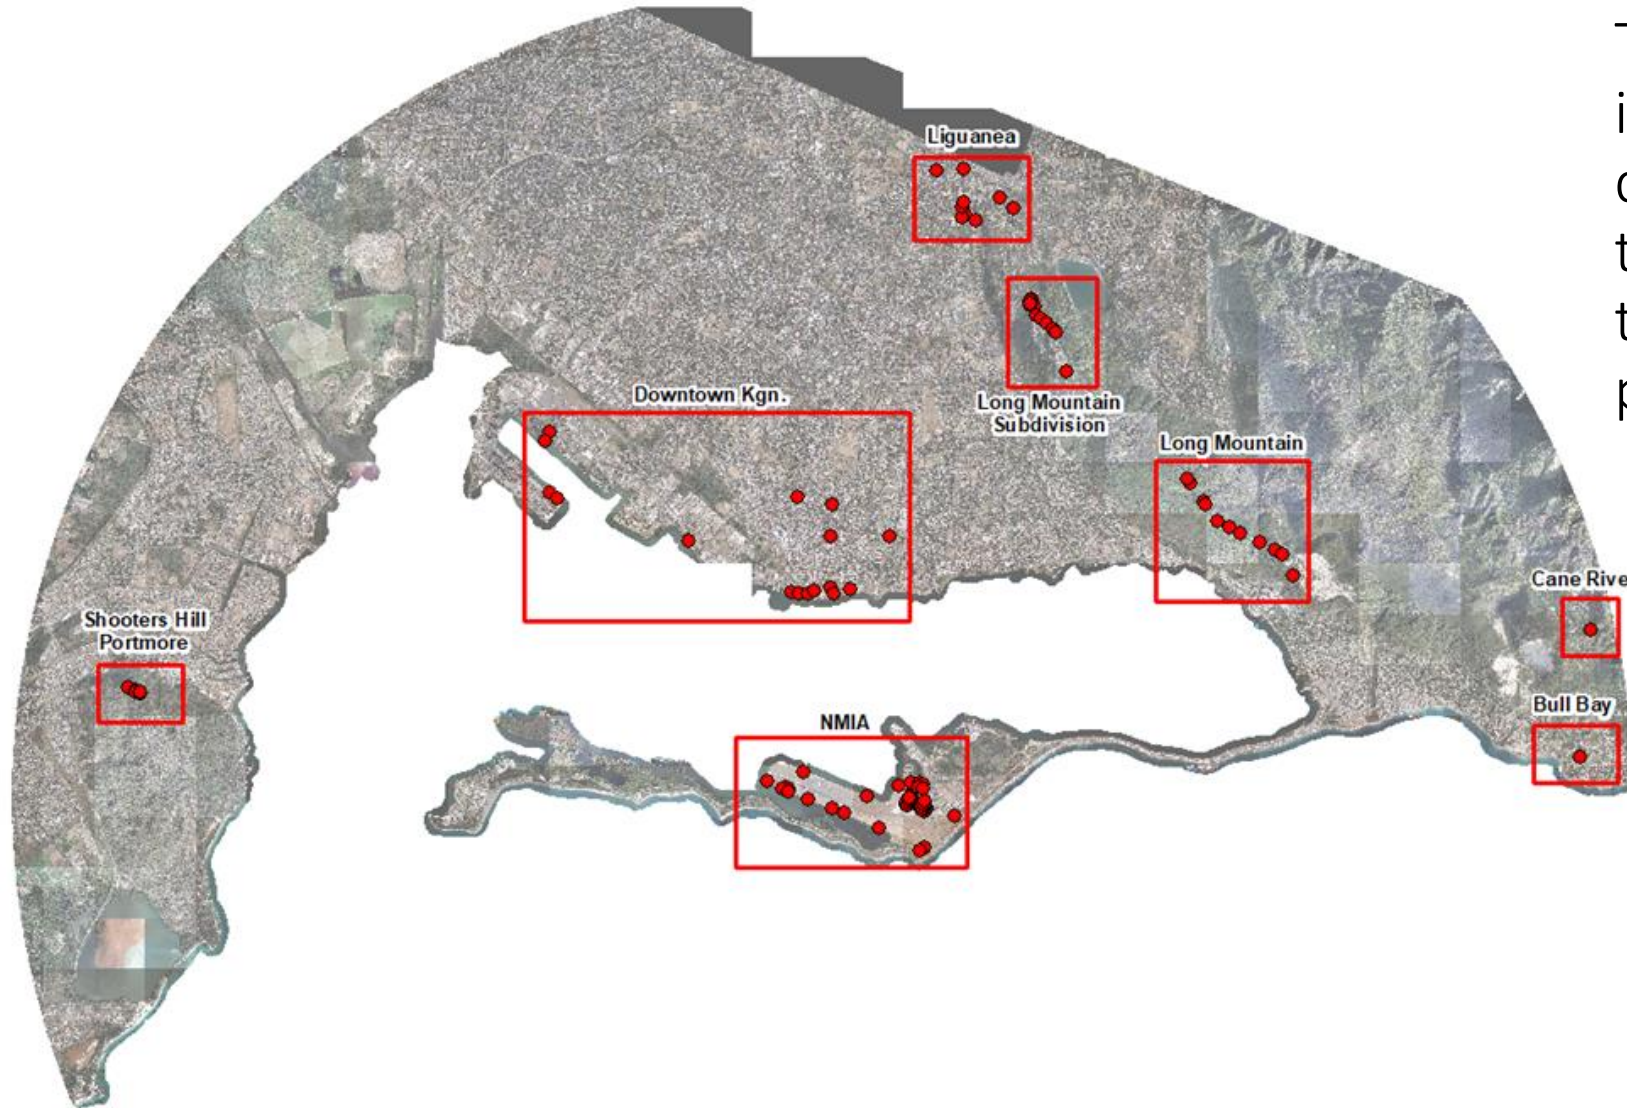
# OLS OBSTACLE VERIFICATION

The verification of the identified obstacles were done using a total station to observe the heights of the highest points of 93 potential obstacles.

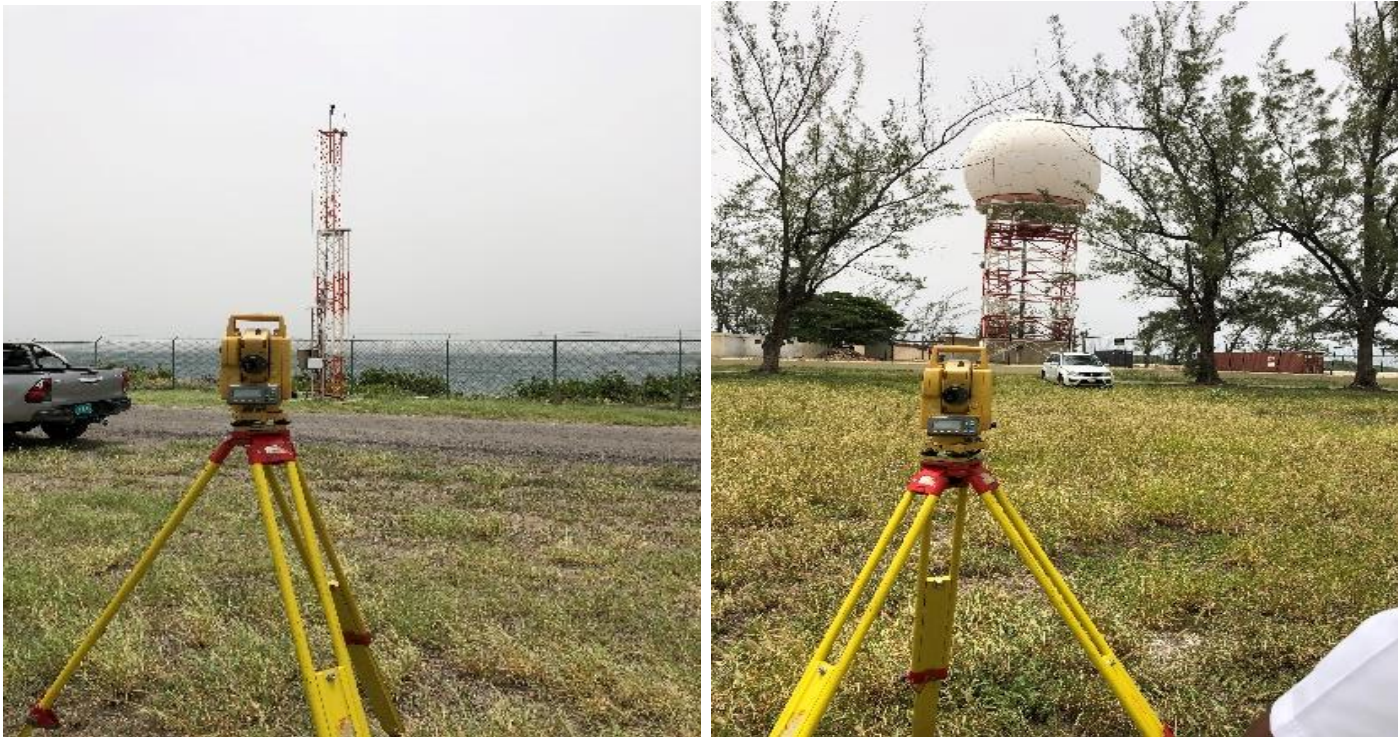
The data for the assets and navigational aids were collected using Global Navigation Satellite System (GNSS) Real-time Kinematic (RTK)

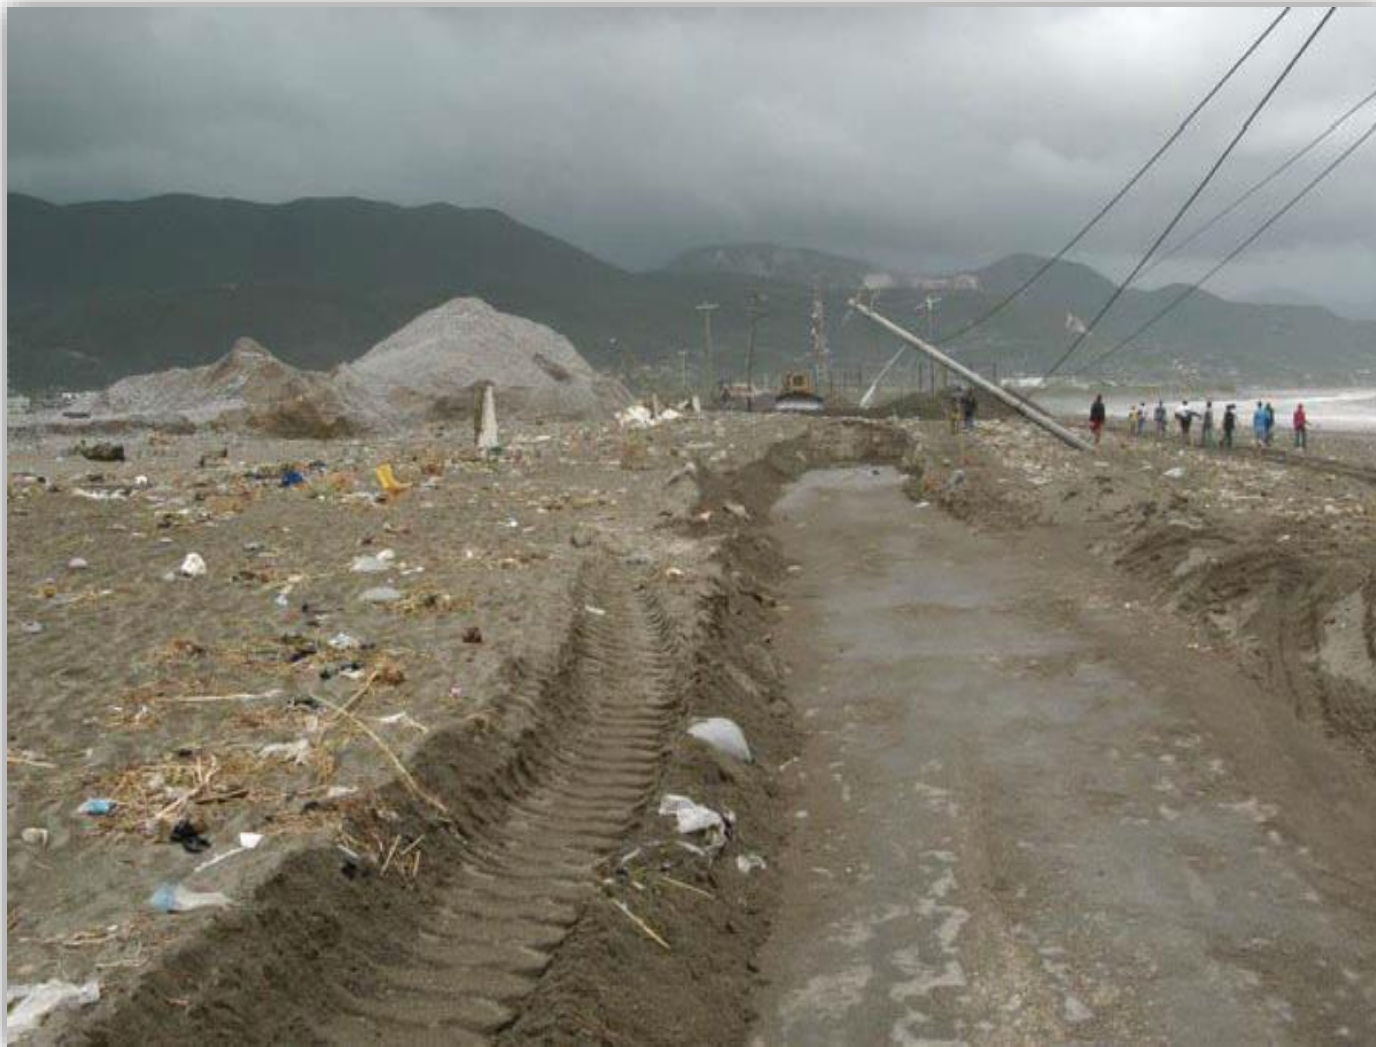
# Impact of Hurricanes

Event Year	Impacts
Hurricane Ivan (2004)	Approximately 310 meters of the shoreline being heavily impacted and overtopped
Dean (2007)	Approximately 2.65km of the shoreline in a critical state
Hurricane Sandy (2012)	Two day shut down of the airport

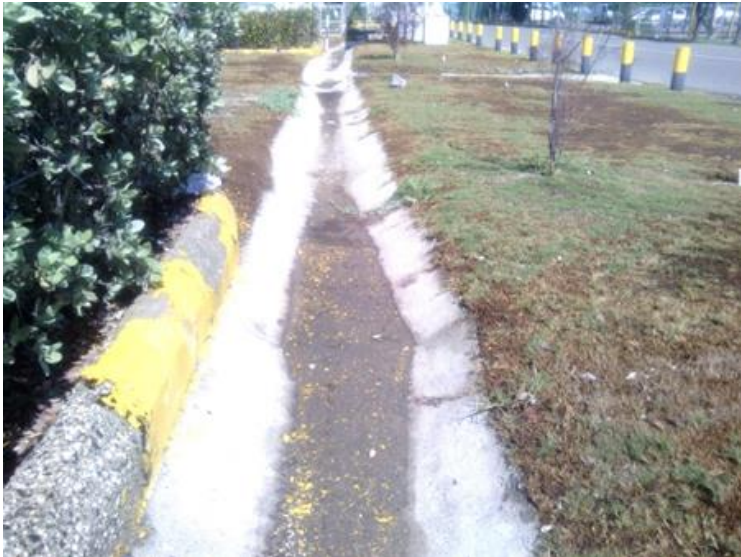
## 1. Rainfall Assessment (Future Climate)

- i. Meteorological related data:
- Daily Rainfall data;
  - Climate change predictions;

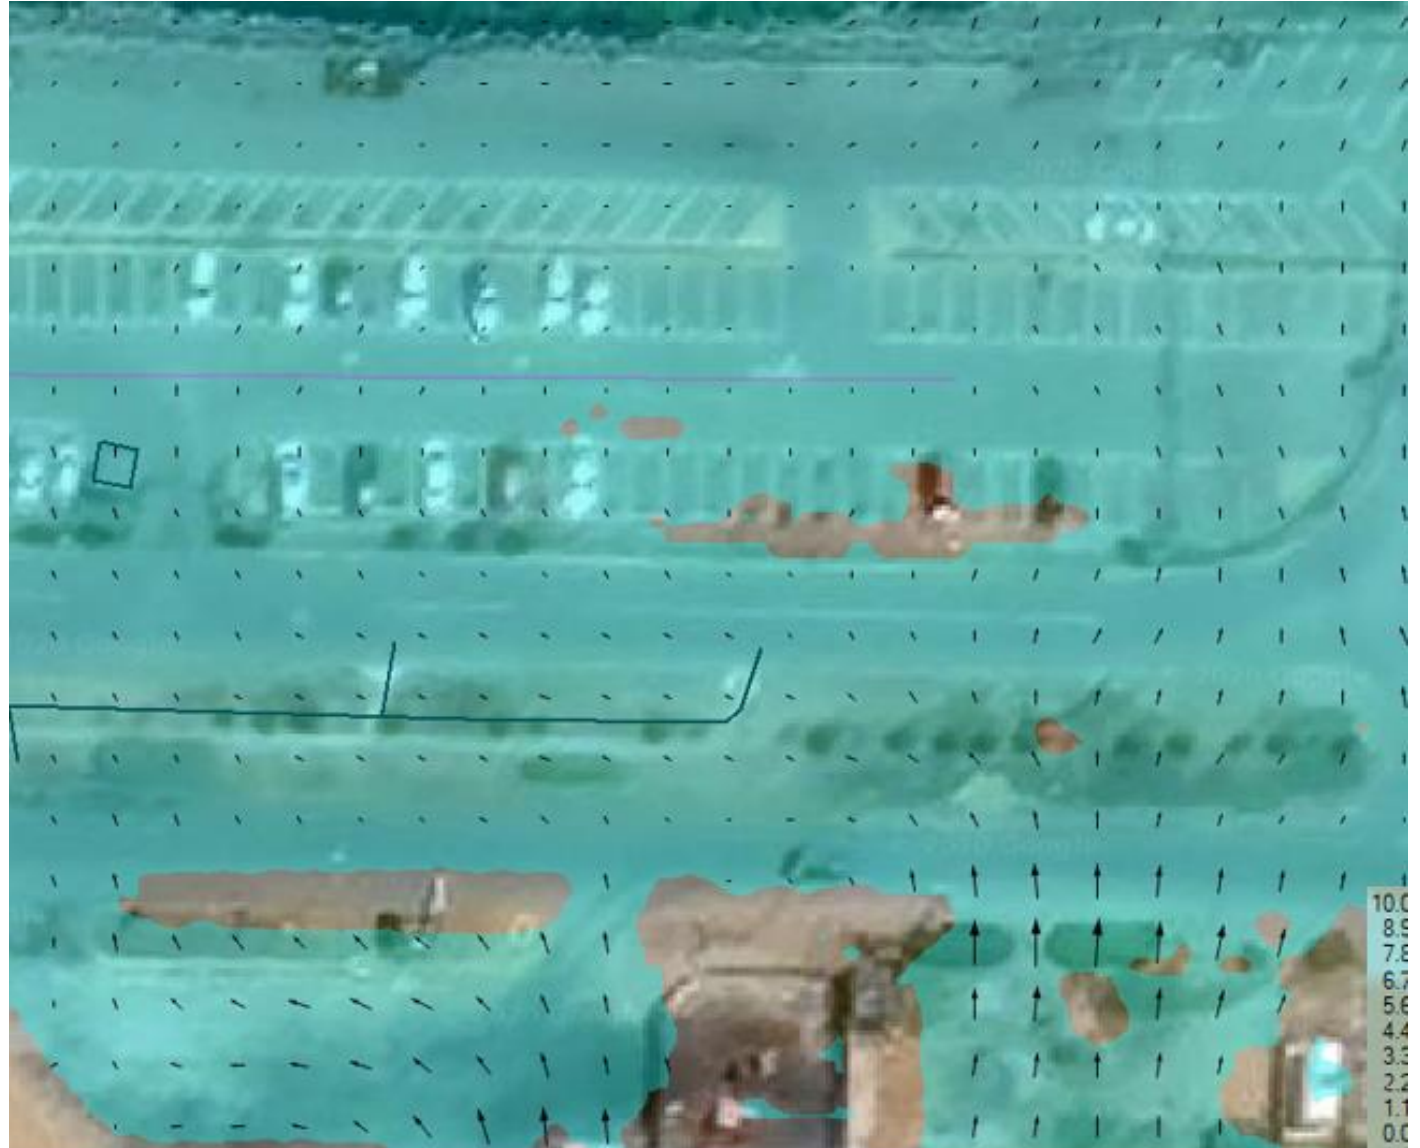
- The results of the flood plain analysis reveal that short term intense rainfall creates widespread inundation but with relatively low flood depths
- Most Vulnerable areas are:
  - Queen's warehouse,
  - car park 14
  - East airfield

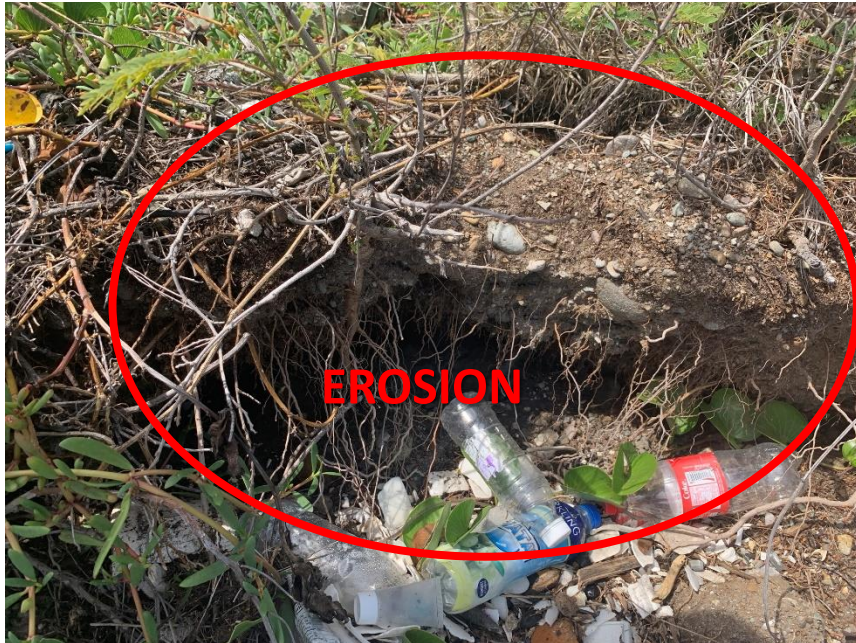
Long Term Inland Reach of Erosion for Future Climate Scenario

It is estimated that sea level rise accounts for approximately 1.2- 28.7 m of erosion along the Harbour side.

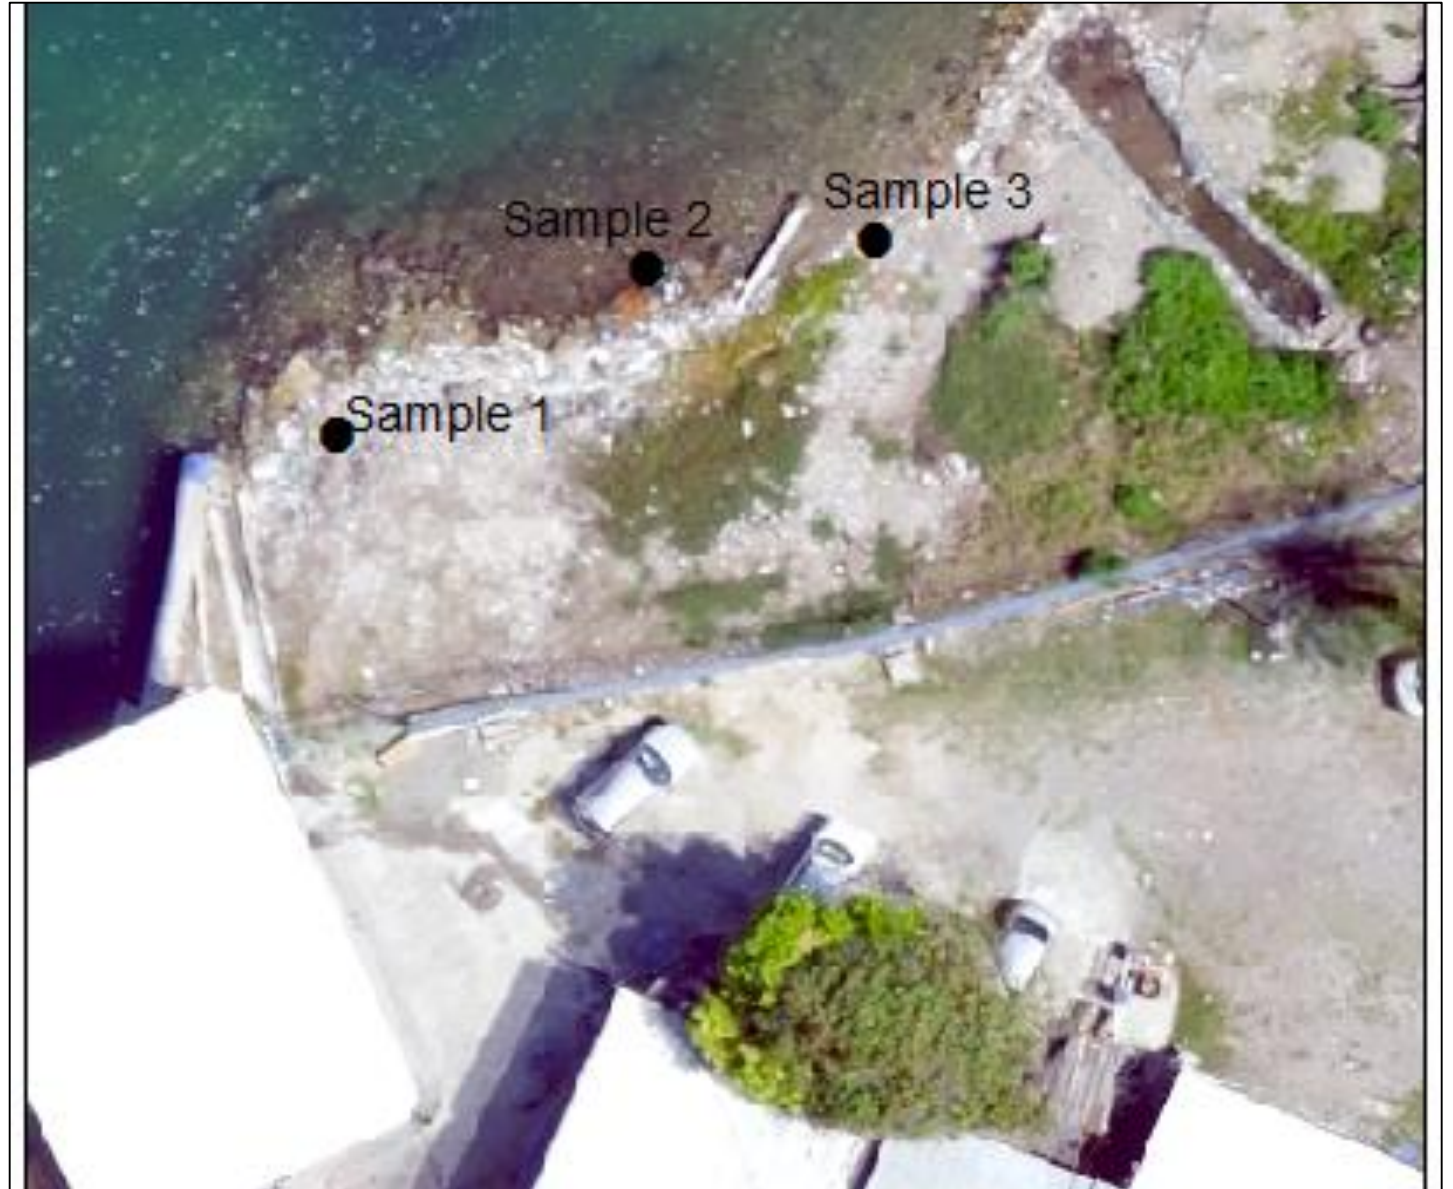
Three (3) sand samples were collected along the shoreline on April 1, 2020.

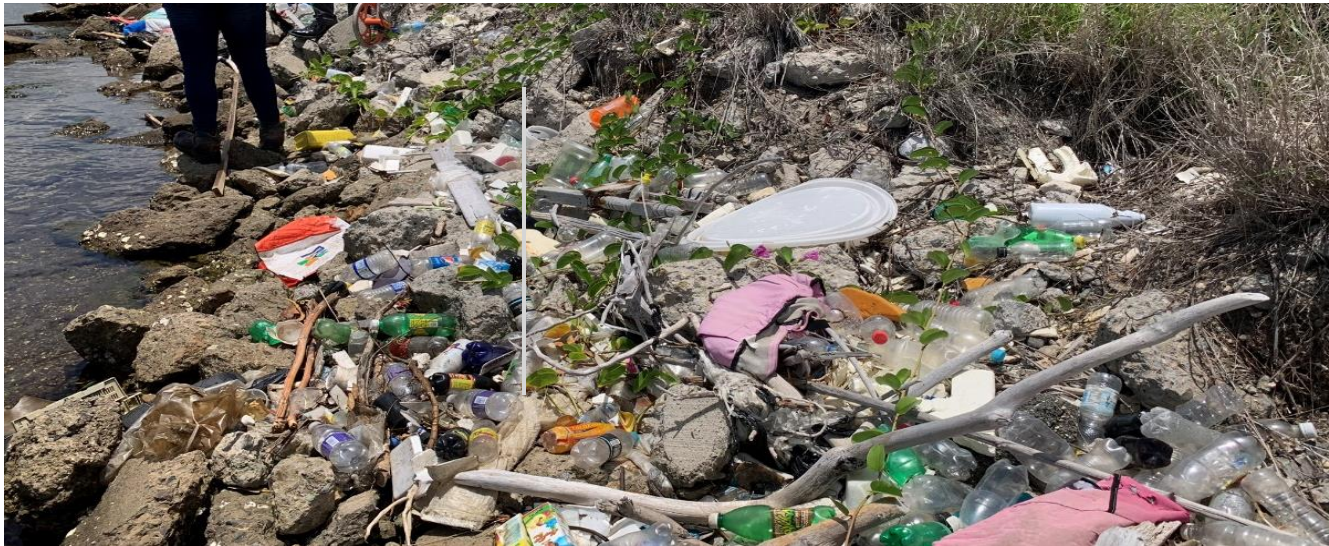
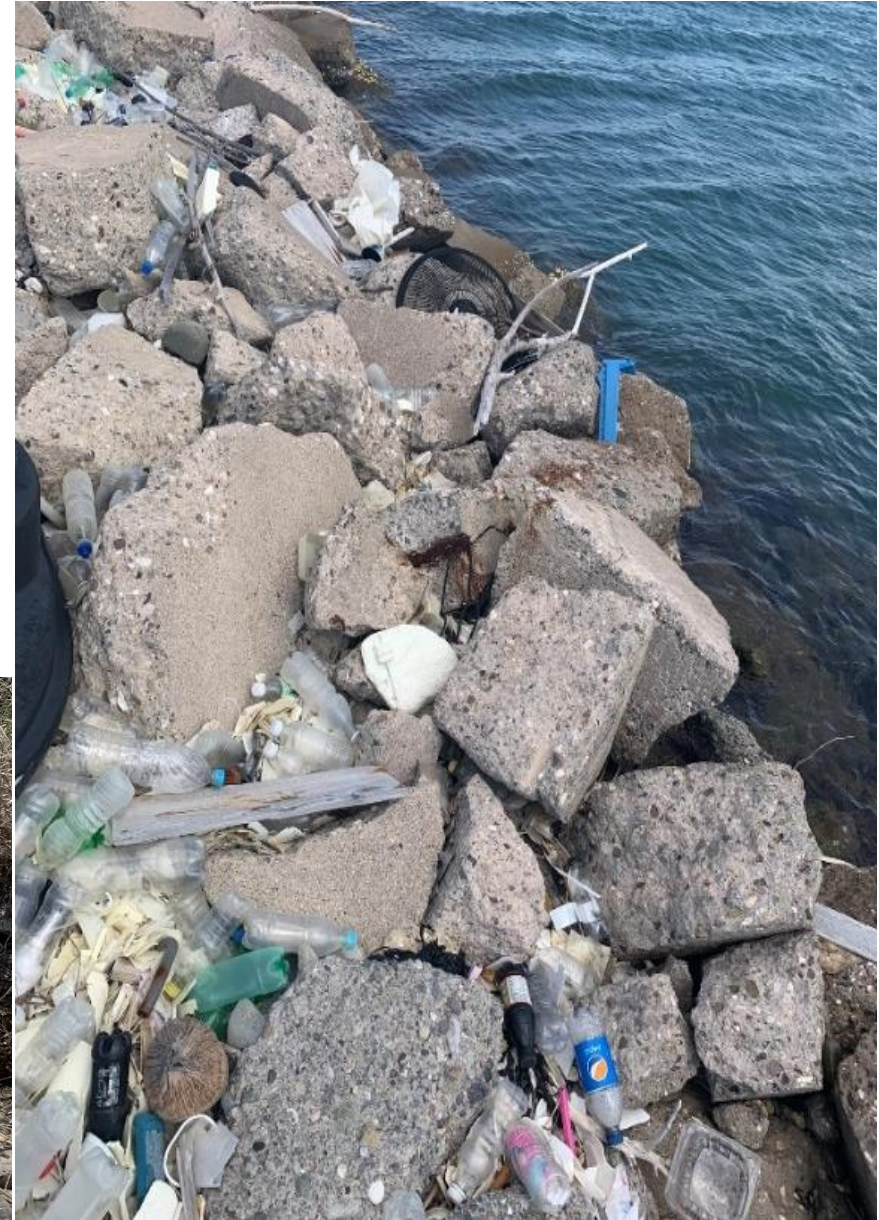
## Revetment and Mangroves Condition Assessment

- On the 16th of June, a Condition Assessment of the revetment and mangroves was undertaken
- The standard damage ratings from descriptions in CIRIA (2007) was used to evaluate the vulnerability and need for rehabilitation or repair.

The standard damage ratings from descriptions in CIRIA (2007) was used to evaluate the vulnerability and need for rehabilitation or repair. Ciria, Cur. "CETMEF (2007)

Revetment	Mangroves	Dunes
No repairs	Slight movement Depressions < ¼ diameter of armour stone Bridging <1/2 diameter	>10 meters width from shoreline to water line	Vegetation width >40 meters and no blow outs
Repairs	Some voids with underlayer visible in some sections	Gaps or breaks in canopy that extend from shoreline to water line >5 meters	Blow outs that extend from dune face part way to back of dune
Rehabilitation	Armour fully displaces Loss of under layer is evident.	Width < 10 meters and breaks in canopy > 5 meters	Vegetation width < 40 meters Blow outs that extend from dune face to back of dune

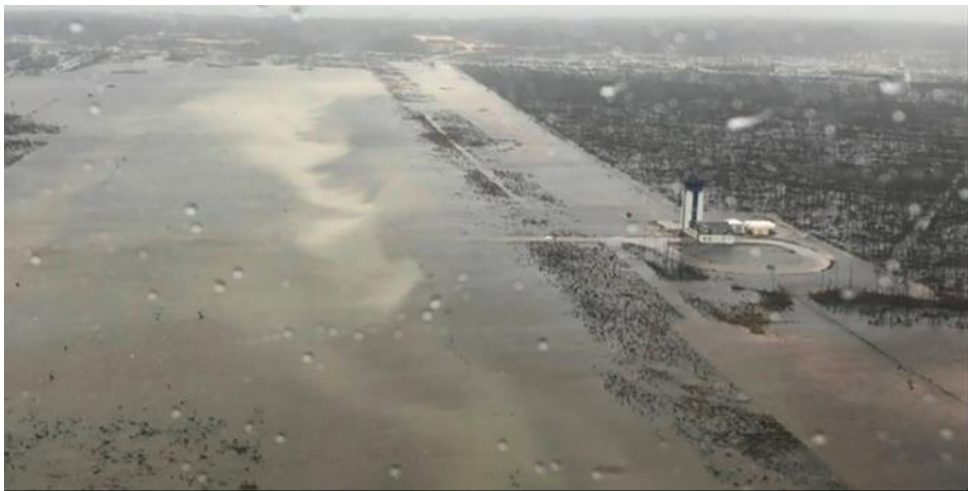
The location of the Norman Manley International Airport defines vulnerability posed by storm surge to be high, particularly with considerations for sea level rise.

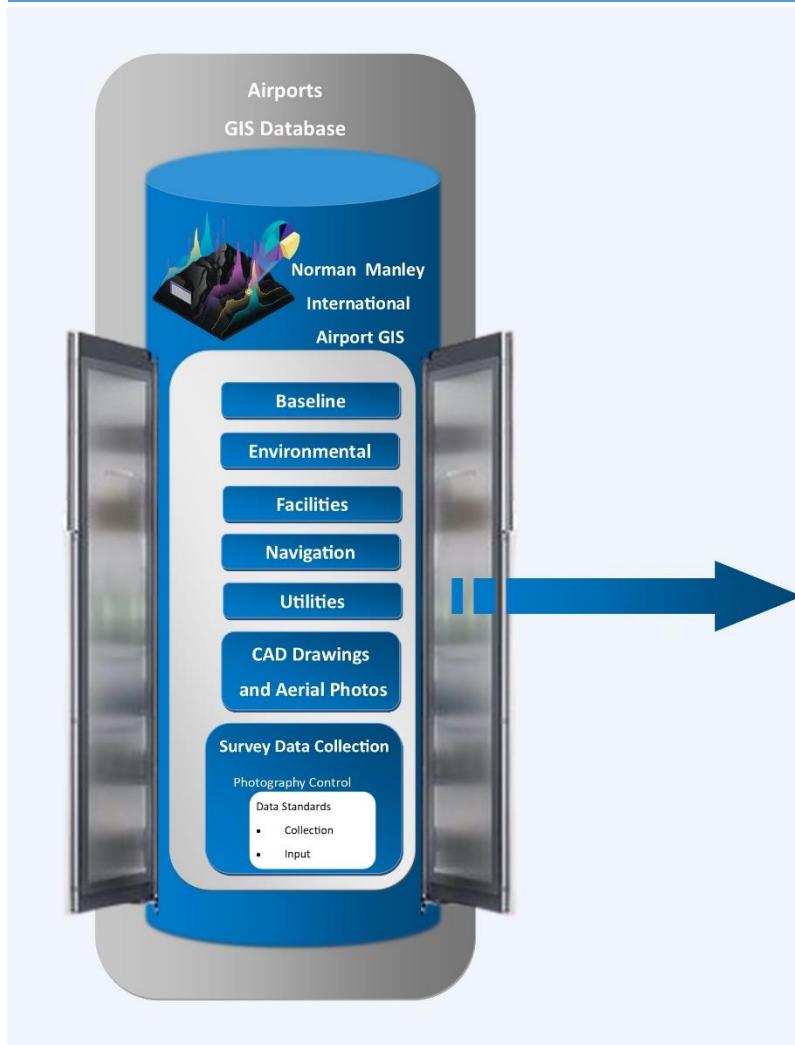
# Airport GIS Database System

These airport features have been categorized into five (5) main feature datasets:

- NMA\_UpdatedDrawings.gdb
- + ■ Baseline
- + ■ Environment
- + ■ Facilities
- + ■ Navigation
- + ■ Utilities
